**City of Greenville St. Andrews Drive–Critical Infrastructure
Protection and Stream Restoration
Project Application– FY2021 BRIC**

City of Greenville St. Andrews Drive – Critical Infrastructure Protection and Stream Restoration

Benefit–Cost Analysis Memorandum

November 22, 2021

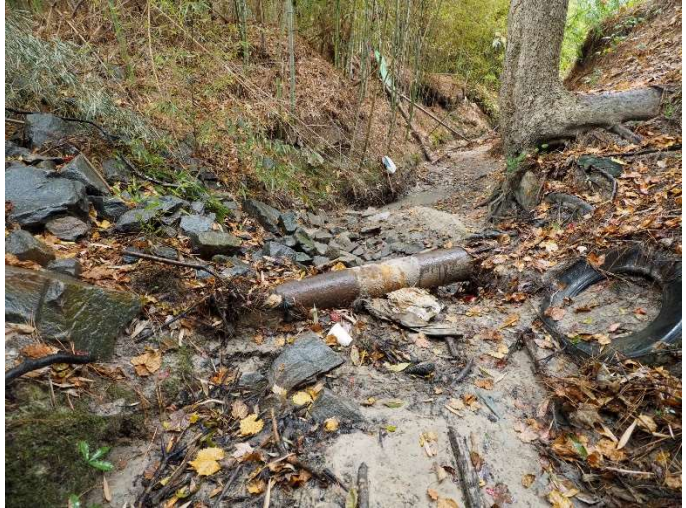
An 8" clay gravity sewer line crosses the stream bed in the project area. Figure 2 demonstrates that the sewer line is fully exposed in the channel and vulnerable to complete failure if impacted by floating debris or the downstream movement of large stones along the streambed. Numerous stormwater pipes also discharge to the channel, and an upward trend in the number of heavy rainfall events (days with more than 3 inches of rain) observed by the North Carolina Climate Science Report indicates that higher flow within the stream is a likely future condition that could cause damage to the sewer line. According to NOAA’s Precipitation Point Frequency Estimates for Greenville, a heavy rainfall event with approximately 3 inches of rain correlates to a 1 to 5-year precipitation event, depending on the duration. Appendix D contains the Greenville, North Carolina NOAA PDS-based point precipitation frequency estimates with 90-percent confidence intervals.

Figure 2. Exposed Sewer Asbestos Cement Pipe Crossing

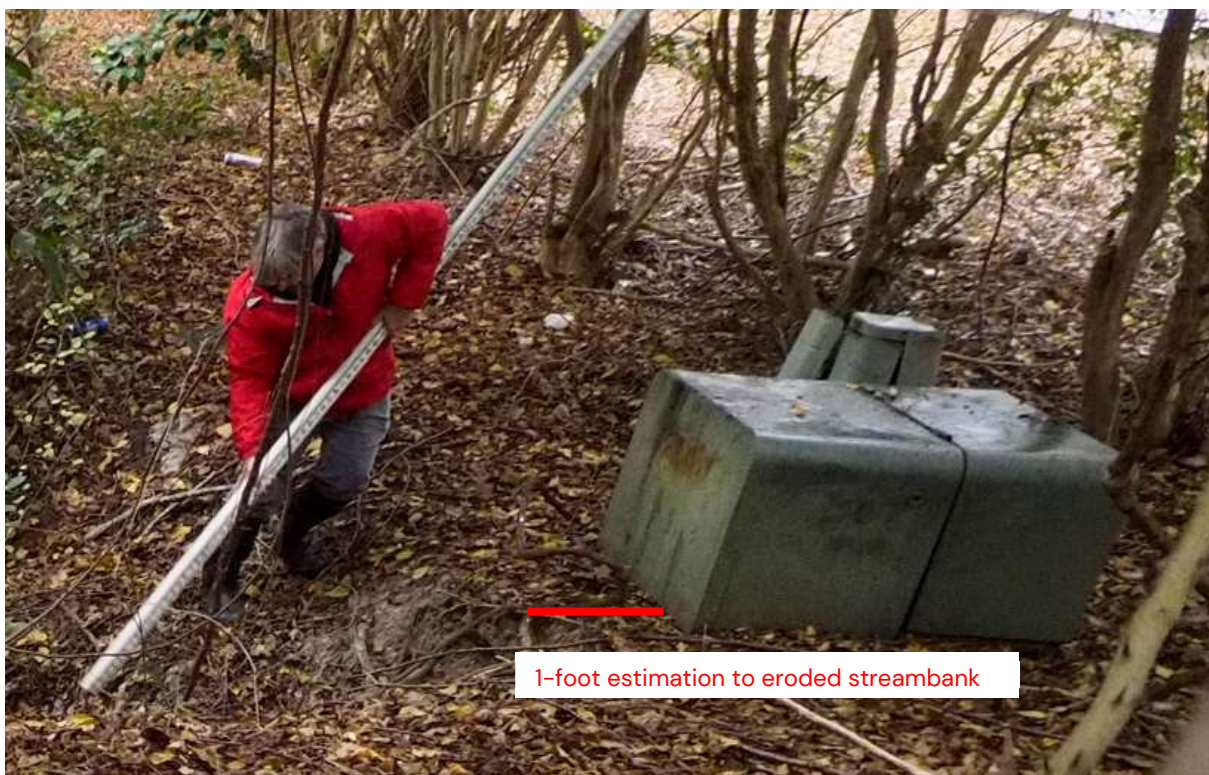
There are two electric transformer boxes that are within inches of the top of actively eroding banks (Figure 3 and Figure 4), and bank erosion has exposed a buried electric service line steel casing (Figure 5, foreground). The transformer boxes and electric service line are vulnerable to failure under erosion conditions; boxes are at risk of falling in the stream if the foundation is undermined by eroding soil. Furthermore, continued and increasing exposure of the electric service line may cause the line to break. These actions threaten electric power service for the expected service population in Table 2 above.

Figure 3. Transformer box near eroded streambank

the proximity of the transformer boxes to the streambed, and severe exposure of electric service lines, analysts estimate that the electrical equipment could fail in the next year if left unprotected. Table 4 presents the assumptions for expected catastrophic failure estimates.

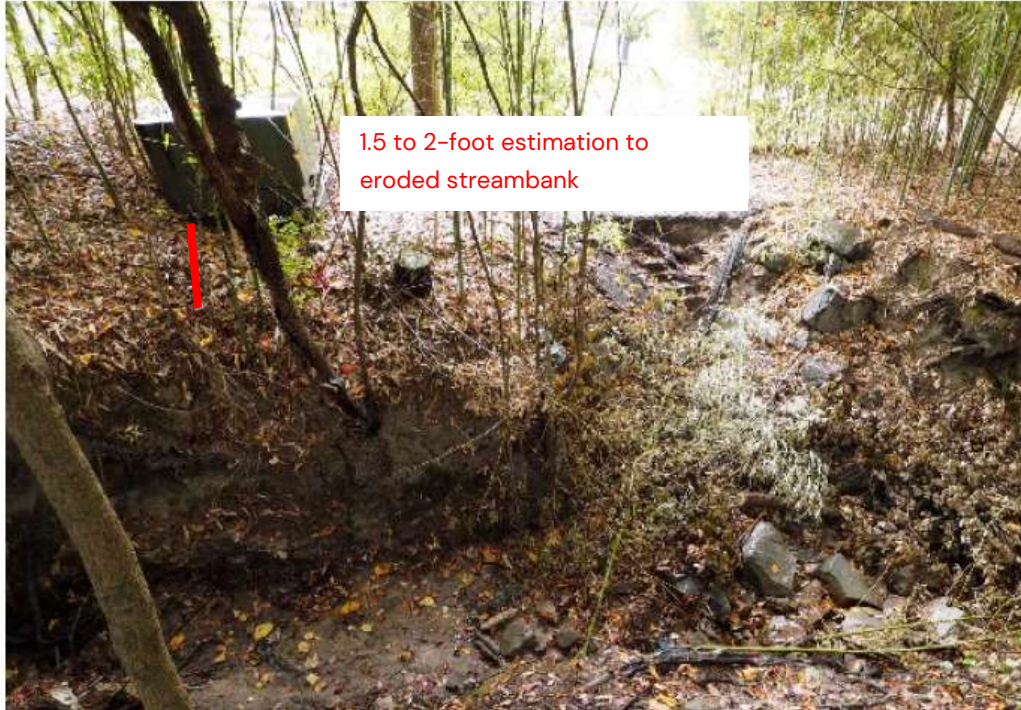
Figure 4. Second transformer box near eroded streambank

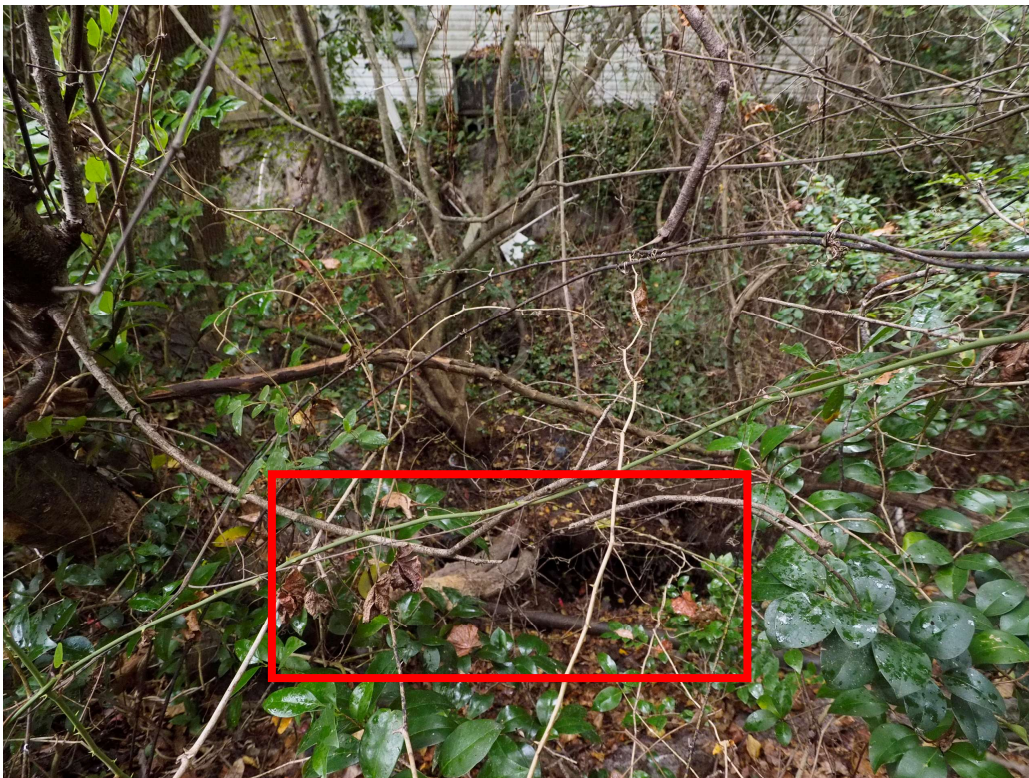
Figure 5. Exposed Steel-Cased Electric Service Line

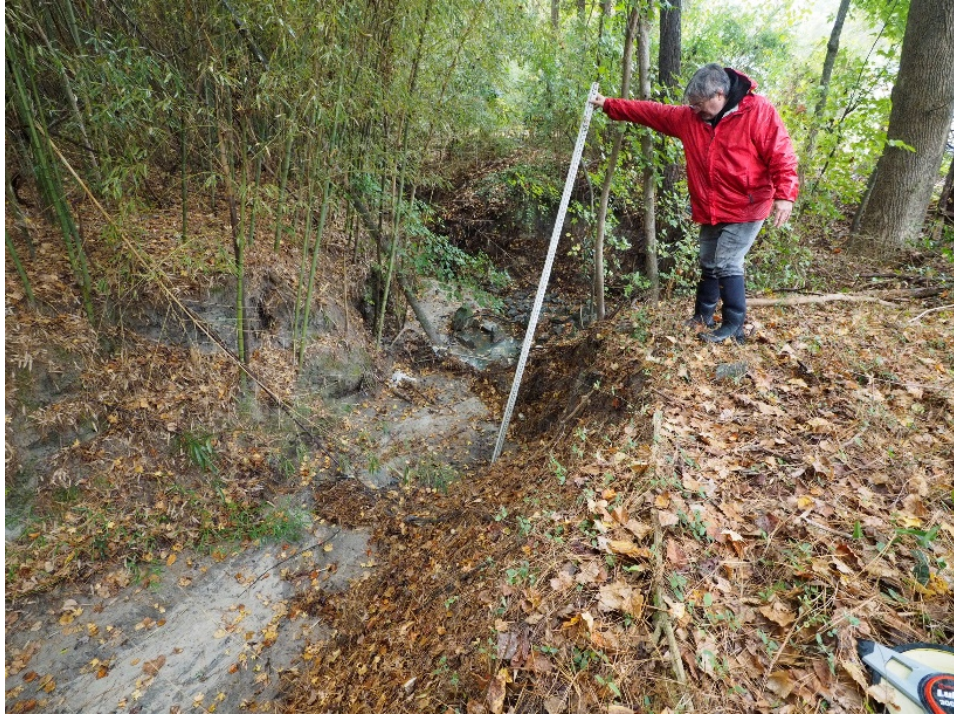
Most of the project stream channel is deeply incised with bank heights of approximately 8 feet to 14 feet (Figure 1). The stream is hydraulically disconnected from its floodplain; the absence of rack lines or other evidence of recent flooding on the adjacent floodplain indicates that the stream is unable to access the floodplain. The channel at the upstream and downstream limits of the project is moderately incised, with bank heights of approximately 3 feet to 4 feet. There is a small section in the upstream area where a low bench was graded into the right bank and is vegetated (Figure 2). Although the left bank is nearly vertical at this location, this stream section appears to be stable because of the beneficial right bench. Existing stream bank revetments (stacked concrete sandbags, riprap, etc.) are present at several locations.

Figure 1. Typical channel erosion, 9 feet deep, 14 feet wide.

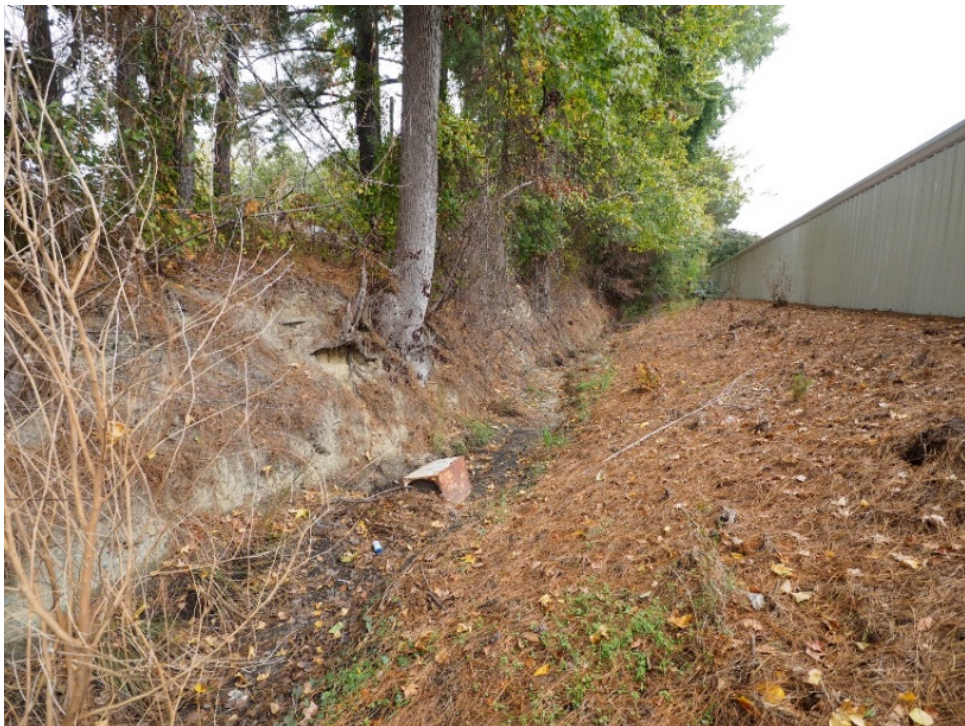
Figure 2. Graded floodplain bench and 2:1 tie-in grading.

- Construct low elevation floodplain benches and grade from the floodplain bench to the existing floodplain at a maximum 2H:1V slope.
- Install stone bank toe (of slope) protection or gabion walls where utilities and structures constrain creation of a floodplain bench.
- Increase the channel bed elevation within most of the restoration channel and specifically over the existing utility crossings to restore their intended subsurface condition.
- Install grade controls (e.g., cross vanes, step pools).
- Stabilize graded and disturbed areas with natural fiber material (coir mat) and plantings (live stakes, shrubs, trees and permanent seeding).

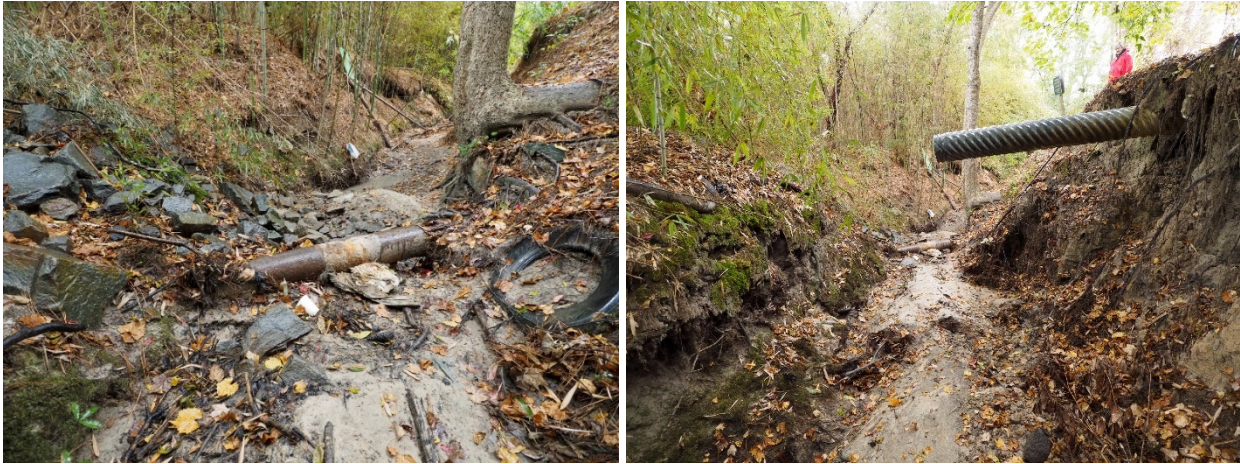
An 8" clay gravity sewer line, an 8" PVC water line and several electric service lines cross the stream bed in the middle section of the project (near alignment station 18+50 on the submitted plans). The sewer line is fully exposed in the channel (Figure 3a) and is vulnerable to complete failure if impacted by floating debris or the downstream movement of large stones along the streambed. Numerous stormwater pipes discharge to the channel (Figure 3b). There are two electric transformer boxes that are close to the top of actively eroding banks and several areas of localized bank scour threaten housing and commercial structures (Figures 4a and 4b). Bank erosion has exposed a buried electric service line steel casing (Figure 5, foreground) and is threatening the structural integrity of a residential building at 313 St. Andrews Drive (Figure 5, background). The top of bank is also close to the Keswick Apartment's pool deck (Figure 6) and several residential fences and outbuildings (Figure 7). Water and gas line are buried near the culvert under Fairlane Road.

Figures 3a & 3b. Exposed sewer line and SW discharge upstream of sewer line.

There is a clay gravity sewer pipe fully exposed in the channel bed near the end of Sedgefield Drive. A water supply line and electric service lines also cross under the channel bed within 50 linear feet of the exposed sewer crossing. The channel bed will be raised to provide one foot of cover (minimum) over the sewer pipe, water line and electric service lines. Grade control structures will be installed immediately upstream, between and downstream of the utility crossings to protect them. A minimum of ten grade controls are recommended over the length of the proposed restoration to prevent future headcut migration and channel incision within the filled and elevated channel bed, and to connect the channel to the floodplain where possible. When a channel is “connected” to its floodplain, high flow events will have access to the adjacent floodplain, will spread out and have reduced water velocities, which will greatly reduce erosive forces (shear forces) within the channel.

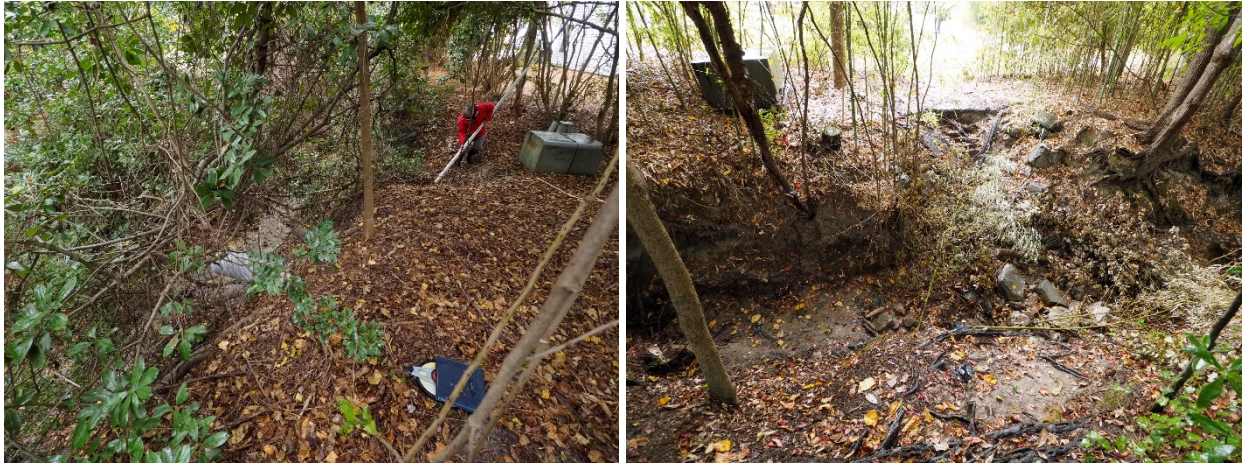
Figure 4a & 4b. Two electric transformer boxes near the top of the bank.

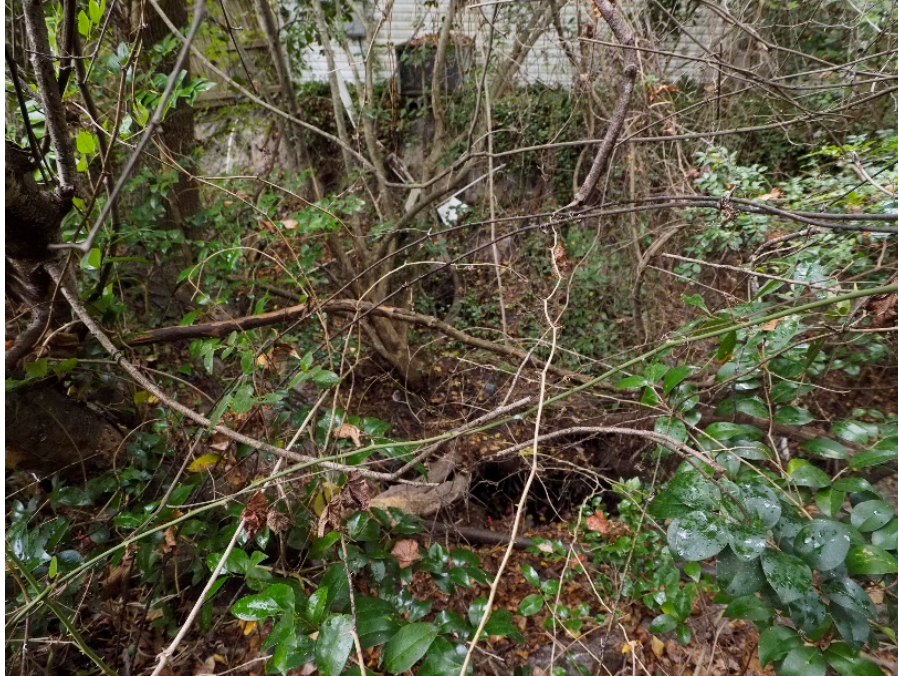
Figure 5. Exposed electric service casing pipe (foreground) and threatened structure (background).

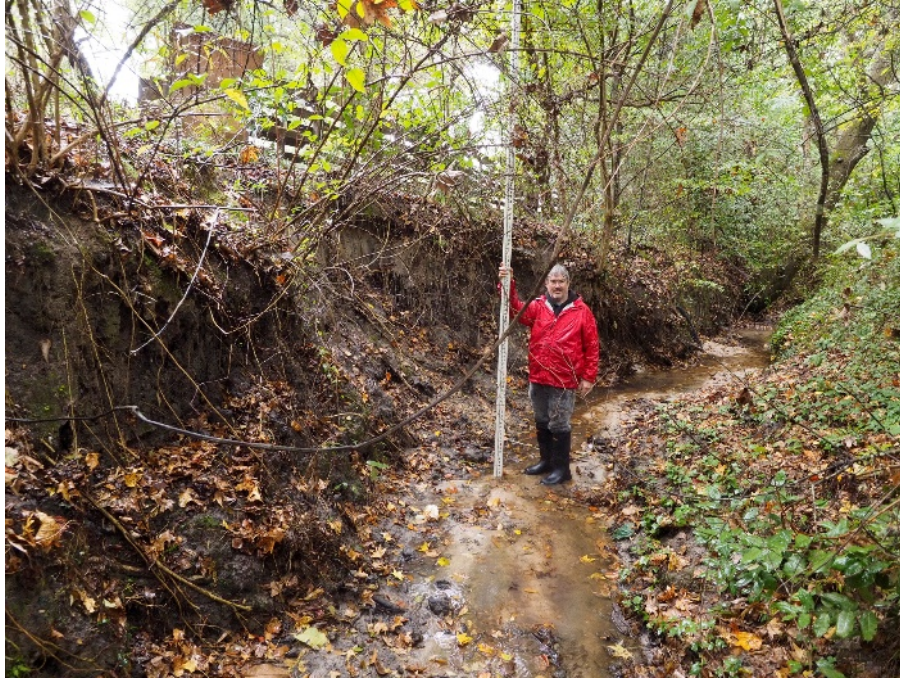
Figure 7. Threatened private fence and outbuilding (visible at top left)

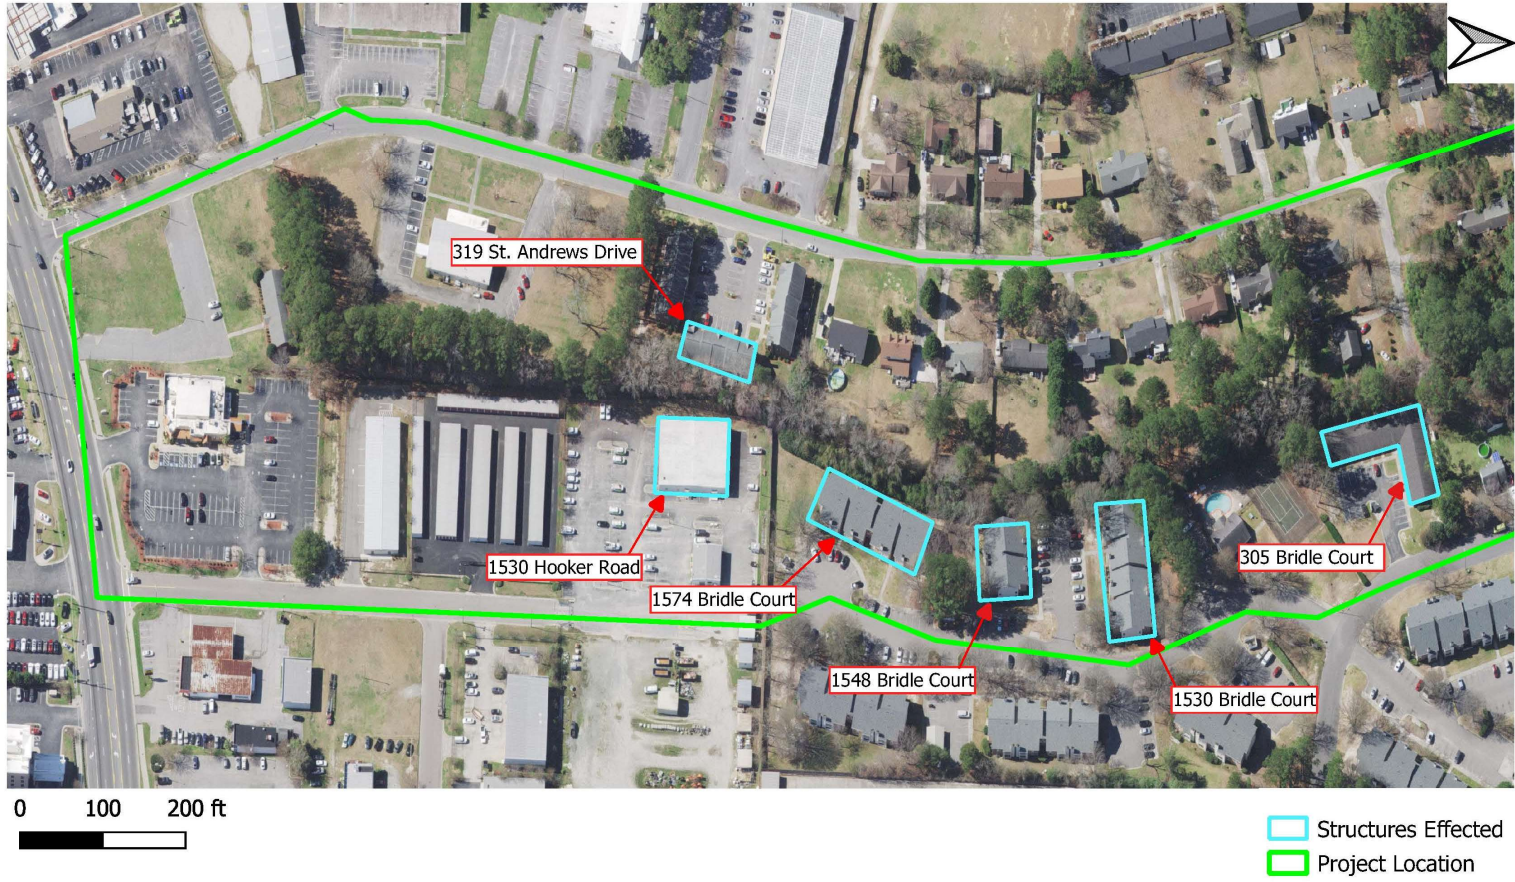
Distance to Streambank Photos
City of Greenville St. Andrews Drive- Critical Infrastructure Protection and Stream Restoration
FY2021 FEMA BRIC Application
Structures Identified for Benefit-Cost Analysis
