**BENEFIT-COST ANALYSIS METHODOLOGY
TOWN OF MOUNT PLEASANT
DOWNTOWN UTILITY DUCT BANK AND STORMWATER
MITIGATION**

**FEMA BUILDING RESILIENT INFRASTRUCTURE AND
COMMUNITIES GRANT PROGRAM**

Cabarrus County, NC

January 6, 2023

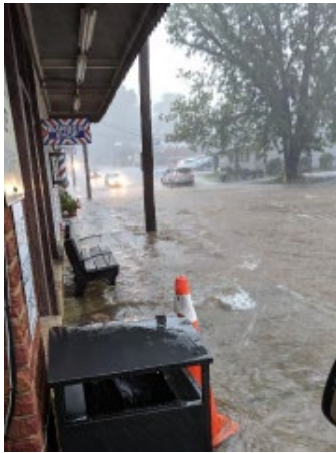
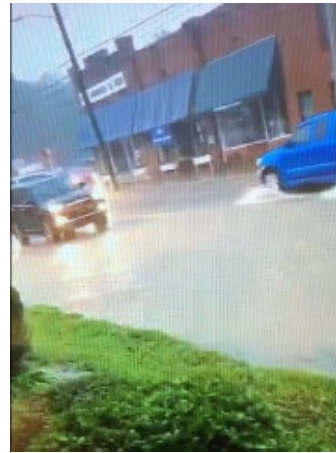
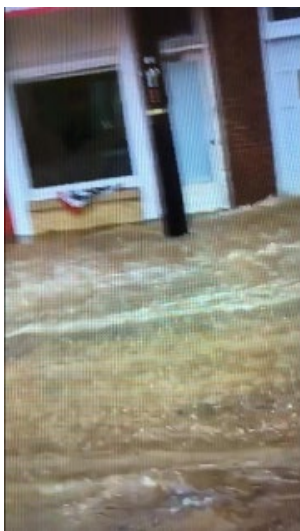
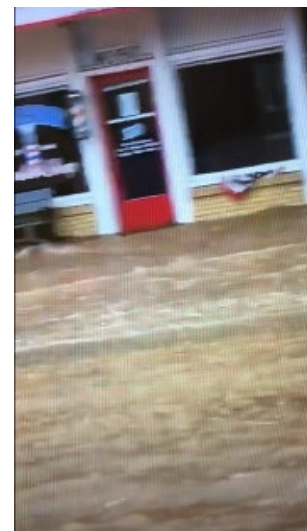
Figure 1: NC 73 – looking west

Figure 2: NC 73 – looking southeast

Figure 3: NC 73 – looking south

Figure 4: NC 73 – looking south

Above in **Figures 1 through 4** are pictures of NC-73, which is a major transportation corridor between the county seats of Albemarle and Concord. The stormwater system was overwhelmed, and rainfall backed up into the street and pooled there. This rendered the roadways un navigable for the residents for a period. The drainage study existing conditions analysis map (attached in **Appendix F**) shows how the system is overwhelmed during major storm events.

Hurricane Florence has been the most recent major flood event that has caused the stormwater system to fail. Mount Pleasant’s stormwater system has also experienced flooding from smaller storms such as 10, 25, and 50-year storms, which produce enough rainfall to cause failure within the system. The Town of Mount Pleasant wants to have a proactive approach, not a reactive approach as it currently does. Community safety is of highest priority for the Town of Mount Pleasant and the stormwater infrastructure component of this project will help to provide the community with a safe and reliable stormwater system.

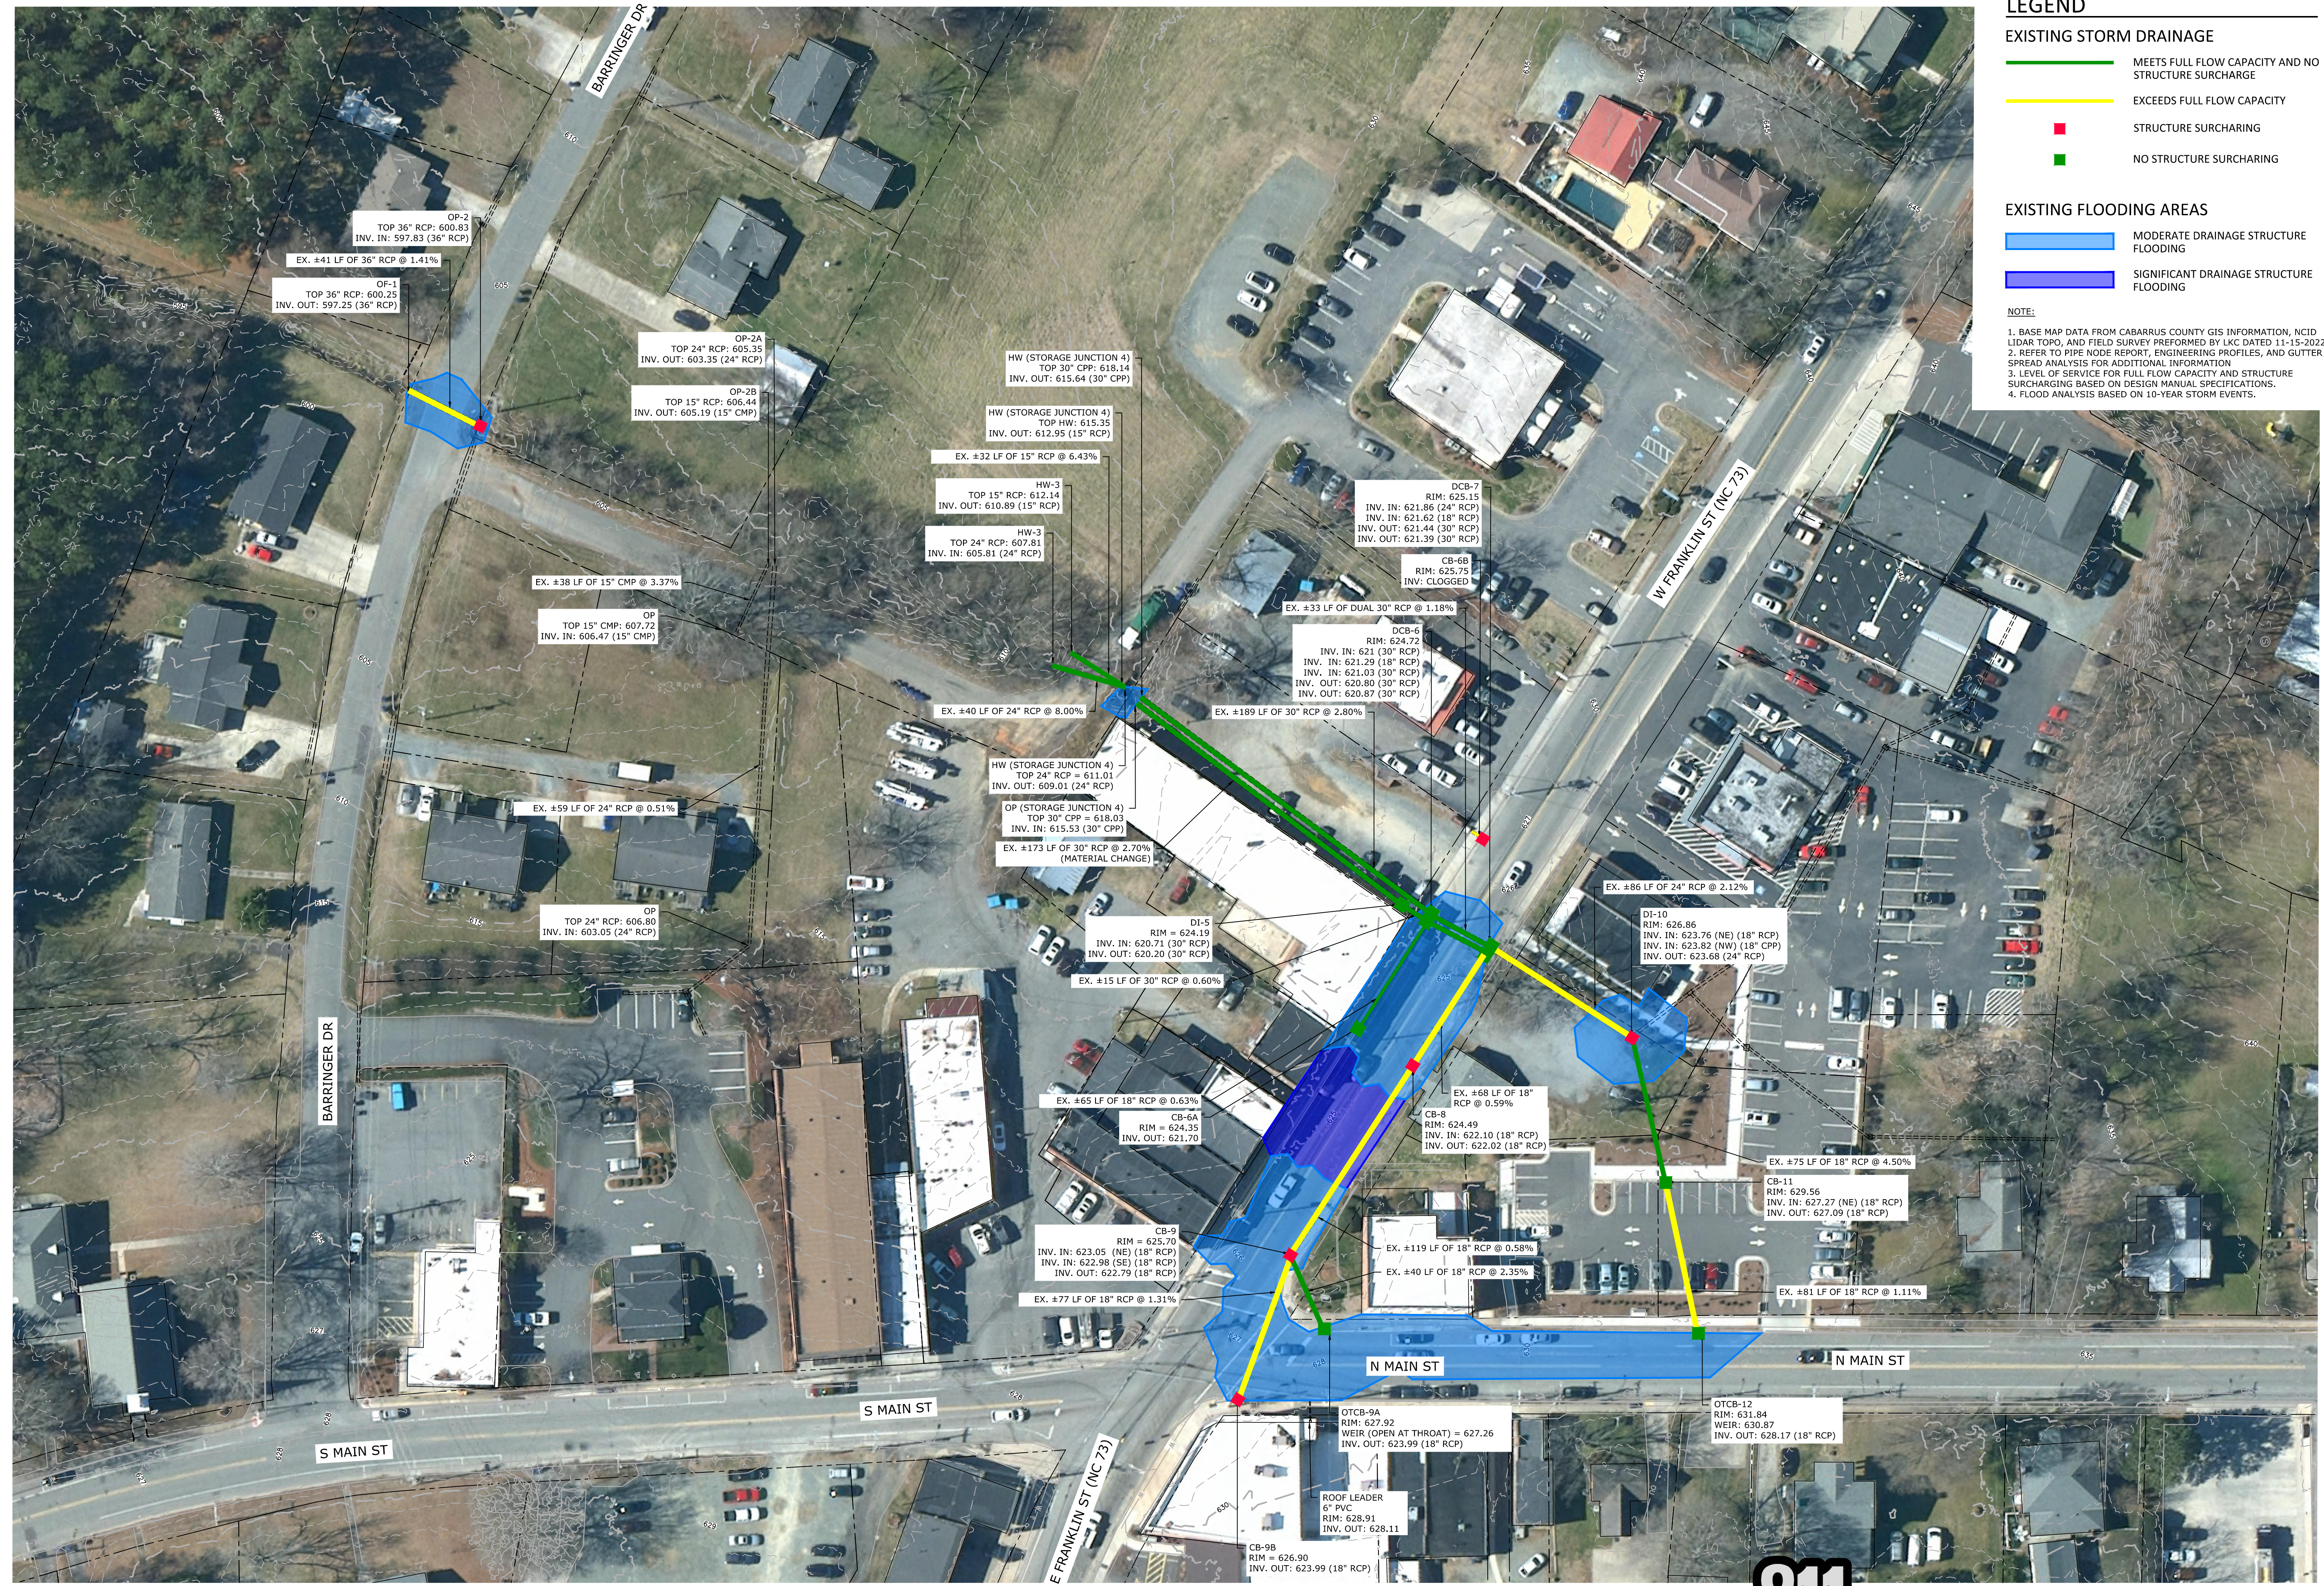
**EXISTING CONDITIONS
INFRASTRUCTURE & FLOODING
E1.06**

**APPENDIX F: DRAINAGE STUDY
EXISTING CONDITIONS ANALYSIS MAP**

**MOUNT PLEASANT
DRAINAGE STUDY
EXISTING CONDITIONS ANALYSIS**
Mount Pleasant, NC, 28124

Based on the StormCAD model provided by McAdams, the existing storm infrastructure begins to fail during a 10-year storm. This failure is what leads to water flooding the Town buildings near the intersection of Main Street and NC 73. As storms causing damage intensify, the estimated damages increase significantly.
